Manhole Inspection Summary

Manhole # S23K__050MH

Insp Date: **6/10/08 7:38 AM**

Location Address: **346 Ramsey**

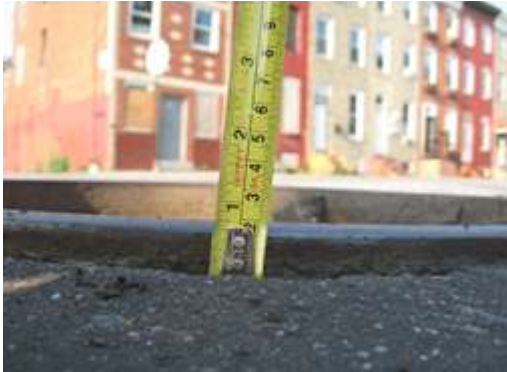
Defect 6

Cover Shape: **Circular** Diameter: **26** (in.) Length: **0** (in.) Dist A/B Grade: **1** (in.)

a/b grade

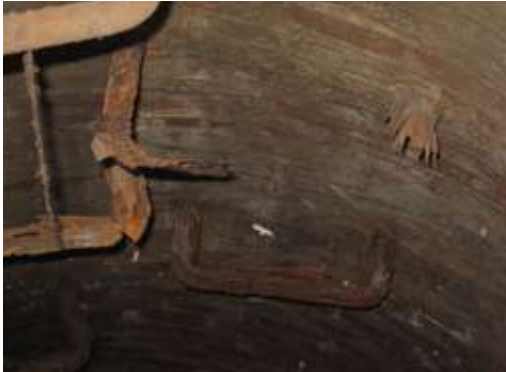
Defect 4

Steps Count: **6** Missing: **3** ☒ **Corroded**

steps missing/corroded

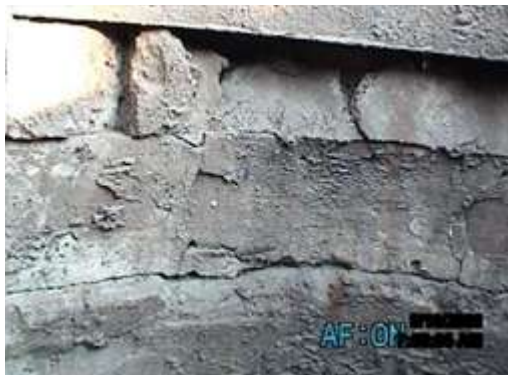
Defect 2

Frame Offset: **0** (in.) Condition: ☐ Sound ☐ Cracked ☒ **Leaks**

Condition: ☐ Sound ☐ Cracked ☐ Root Intrusion ☐ Loose Brick ☒ **Deteriorated**

Infiltration: ☐ None ☒ **Joint** ☒ **Cracks** ☒ **Mortar** ☐ Roots ☐ Wall

frame leaks, chimney deteriorated with signs of infiltration at joint/crack/mortar

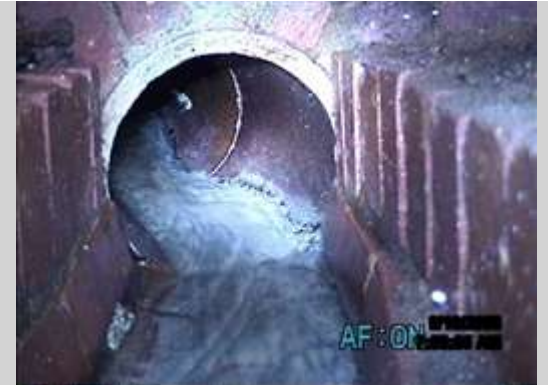
12 O'Clock Outflow

8 in. Circular Gravity Sewer
Pipe Out @ 12 O'Clock

Pipe Height: **8.4** (in.) Rod and Bar (Angled)
Pipe Material: **Clay** ☐ Pipe Lined
Invert Depth: **10.21** (ft.) Flow Characteristics: **Fast**
Deposits: ☒ None ☐ Mud ☐ Sludge ☐ Debris ☐ Grease
Silt Depth: **0** (in.) Deposits Extent:
Infiltration: **None** Pipe Seal Cond: **Sound**

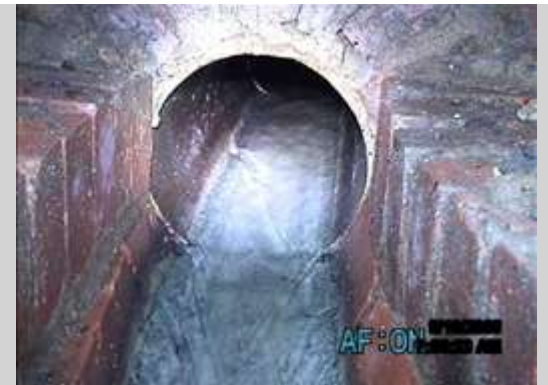
6 O'Clock Inflow

8 in. Circular Gravity Sewer
Pipe In @ 6 O'Clock

Pipe Height: **8.4** (in.) Rod and Bar (Angled)
Pipe Material: **Clay** ☐ Pipe Lined
Invert Depth: **10.04** (ft.) Flow Characteristics: **Fast**
Deposits: ☒ None ☐ Mud ☐ Sludge ☐ Debris ☐ Grease
Silt Depth: **0** (in.) Deposits Extent:
Infiltration: **None** Pipe Seal Cond: **Sound**
